The Original Engine Cooling Pump Since 1921

18000 Pump Series Technical Guide

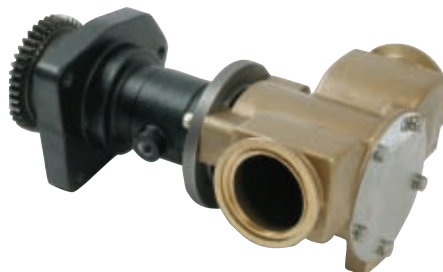
**G1808, G18081-01, G18082-01*
and G18082X***

*G18082-01 and G18082X do not have the oil tap shown in the pump bearing body.

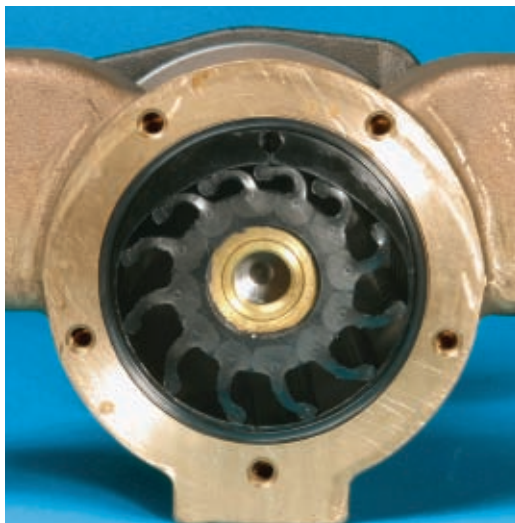
Vanes flipped to the left
(viewed from cover).

Models: G1808, G18081-01, G1810, G1810-01,
G1814-01, G18082, G1814X, G1811-01 and G1816-01
